## NBS SPECIAL PUBLICATION 622

# Detection, Diagnosis and Prognosis: Contribution to the Energy Challenge

Proceedings of the 32nd Meeting of the  
Mechanical Failures Prevention Group,  
held at the Inn at Santa Monica,  
Santa Monica, California, October 7-9, 1980

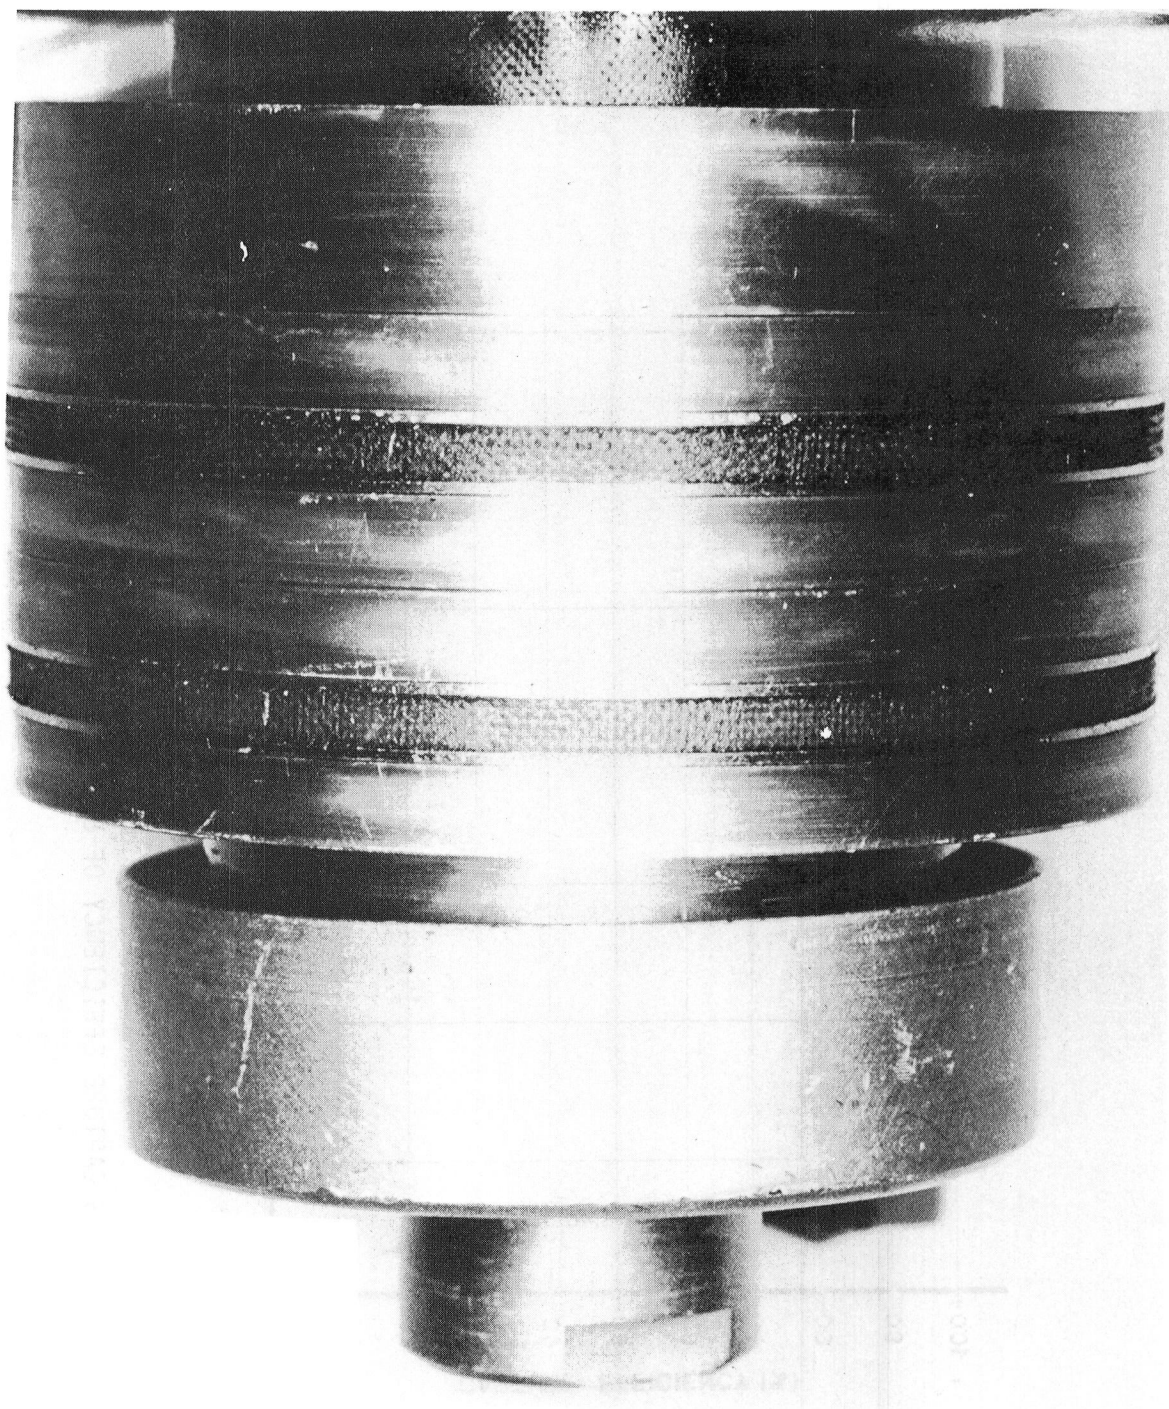
FIGURE 5: TRANSMISSION FULL-FLOW CHIP DETECTOR

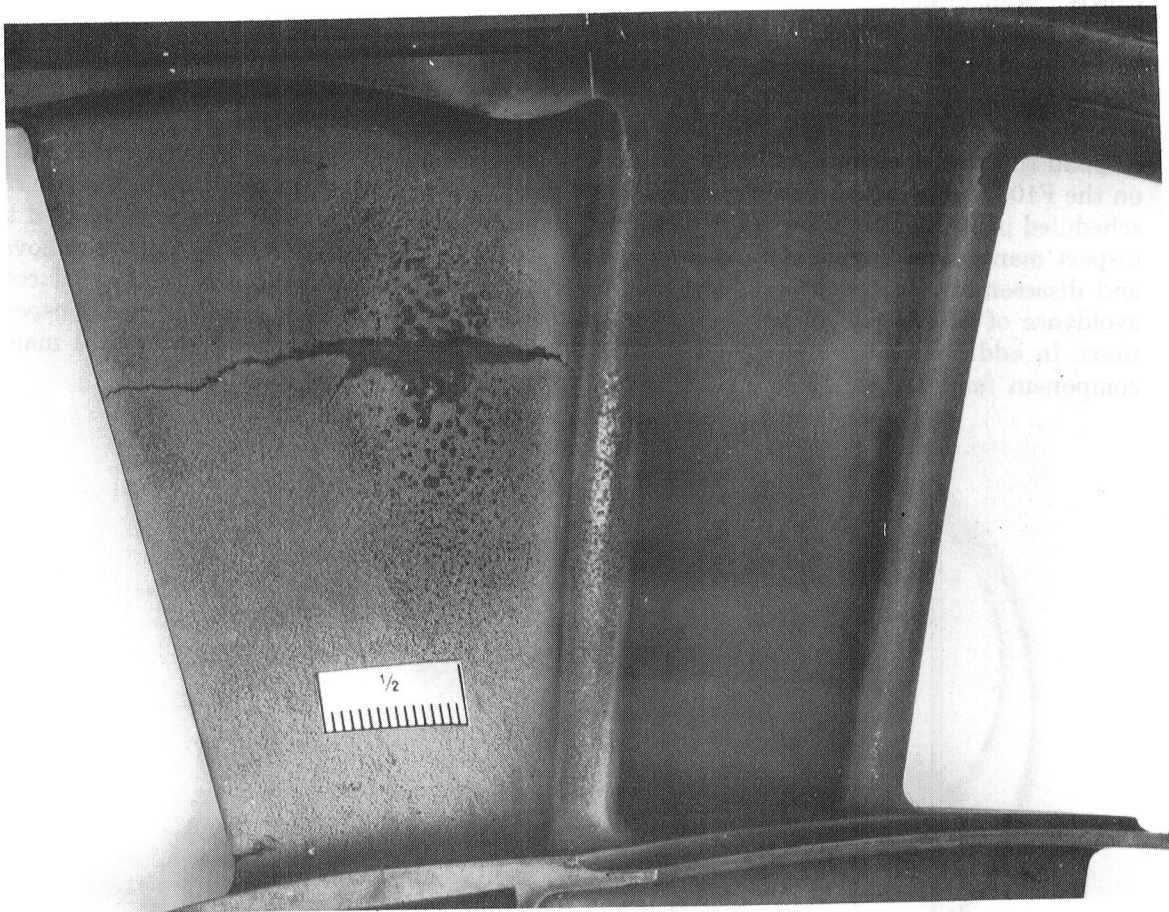
*Figure 5. Actual Turbine Vane Damage*

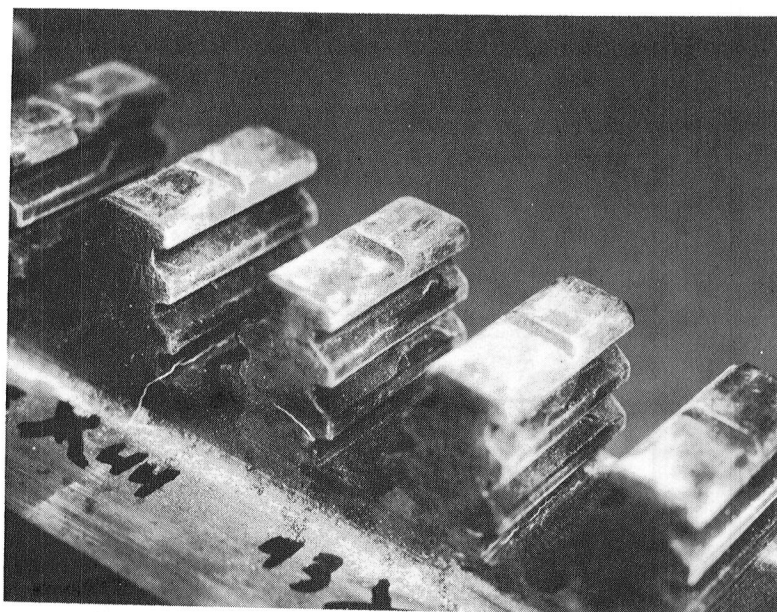
FIGURE 7. DISC RIM MAGNETIC PARTICLE CRACK INDICATIONS  
FOR FIR TREE ROOT
